DETAILED LANDSLIDE AND FLOOD HAZARD MAP OF **4019-II-25 MASAO QUADRANGLE**

PUBLISHED DECEMBER 2015

MINES AND GEOSCIENCES BUREAU

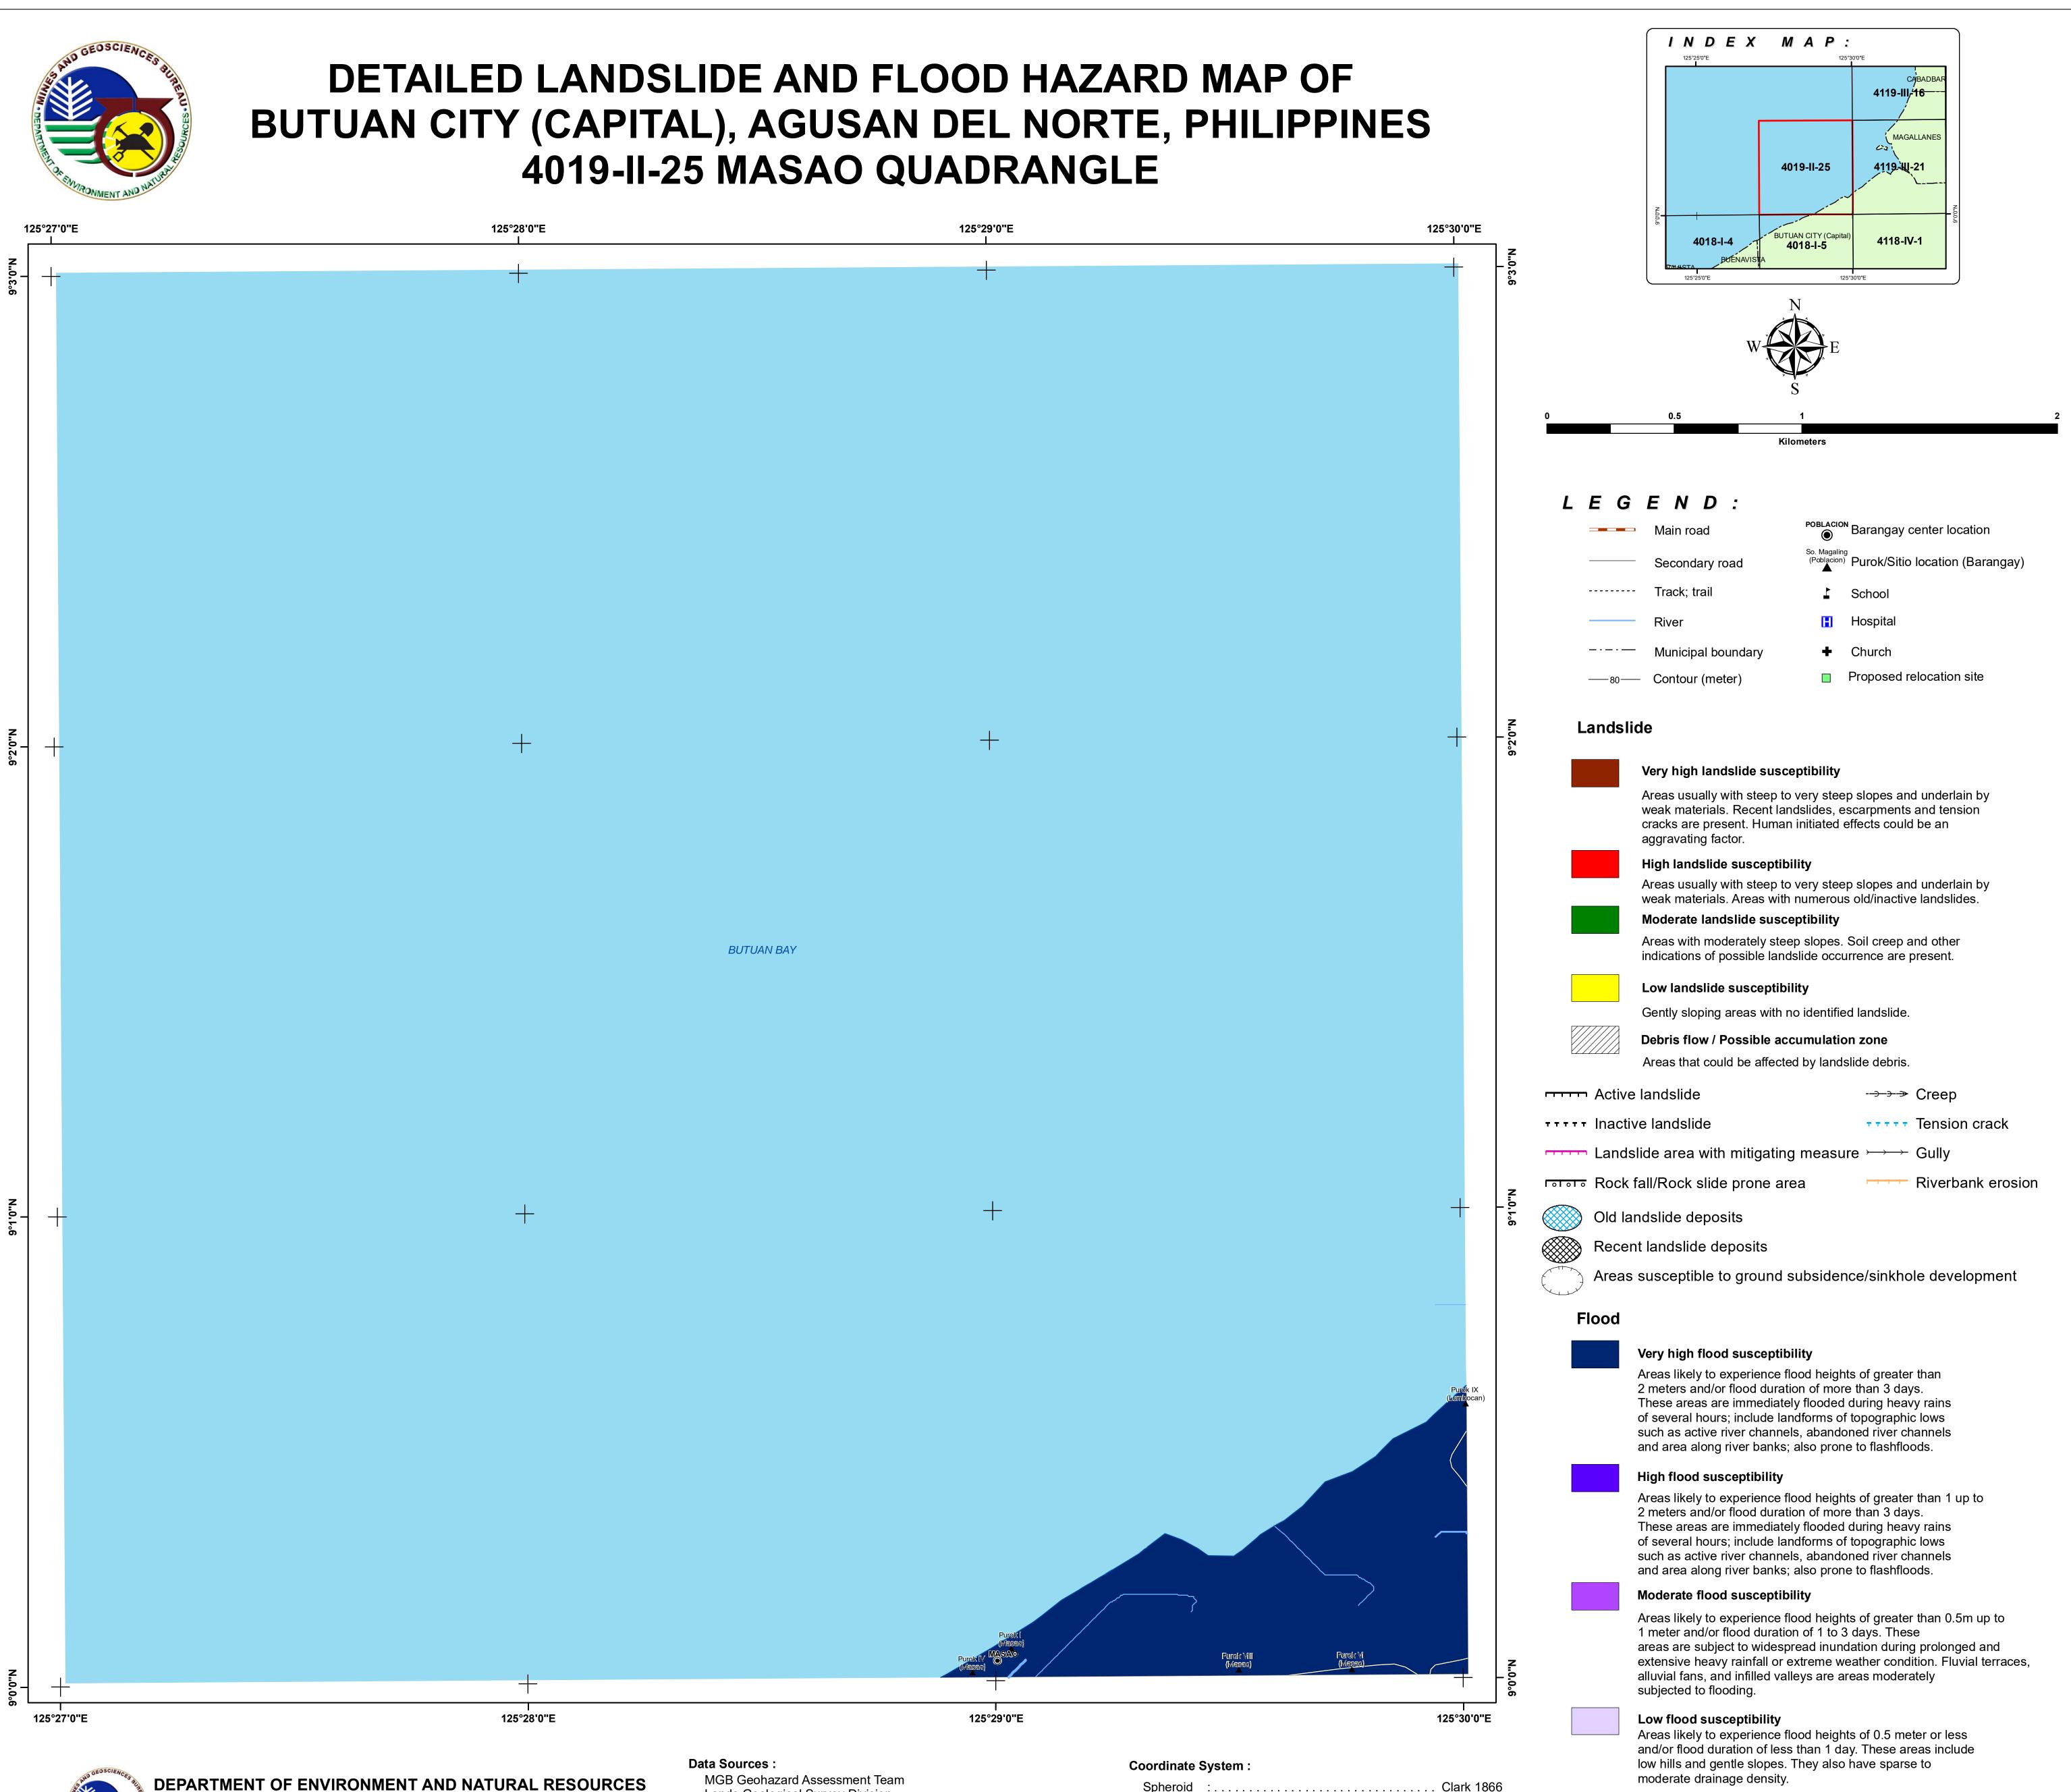
Mapping scale 1:10,000
