DETAILED LANDSLIDE AND FLOOD HAZARD MAP OF 4118-IV-13 MAIBU QUADRANGLE

DEPARTMENT OF ENVIRONMENT AND NATURAL RESOURCES MINES AND GEOSCIENCES BUREAU North Avenue, Diliman, Quezon City

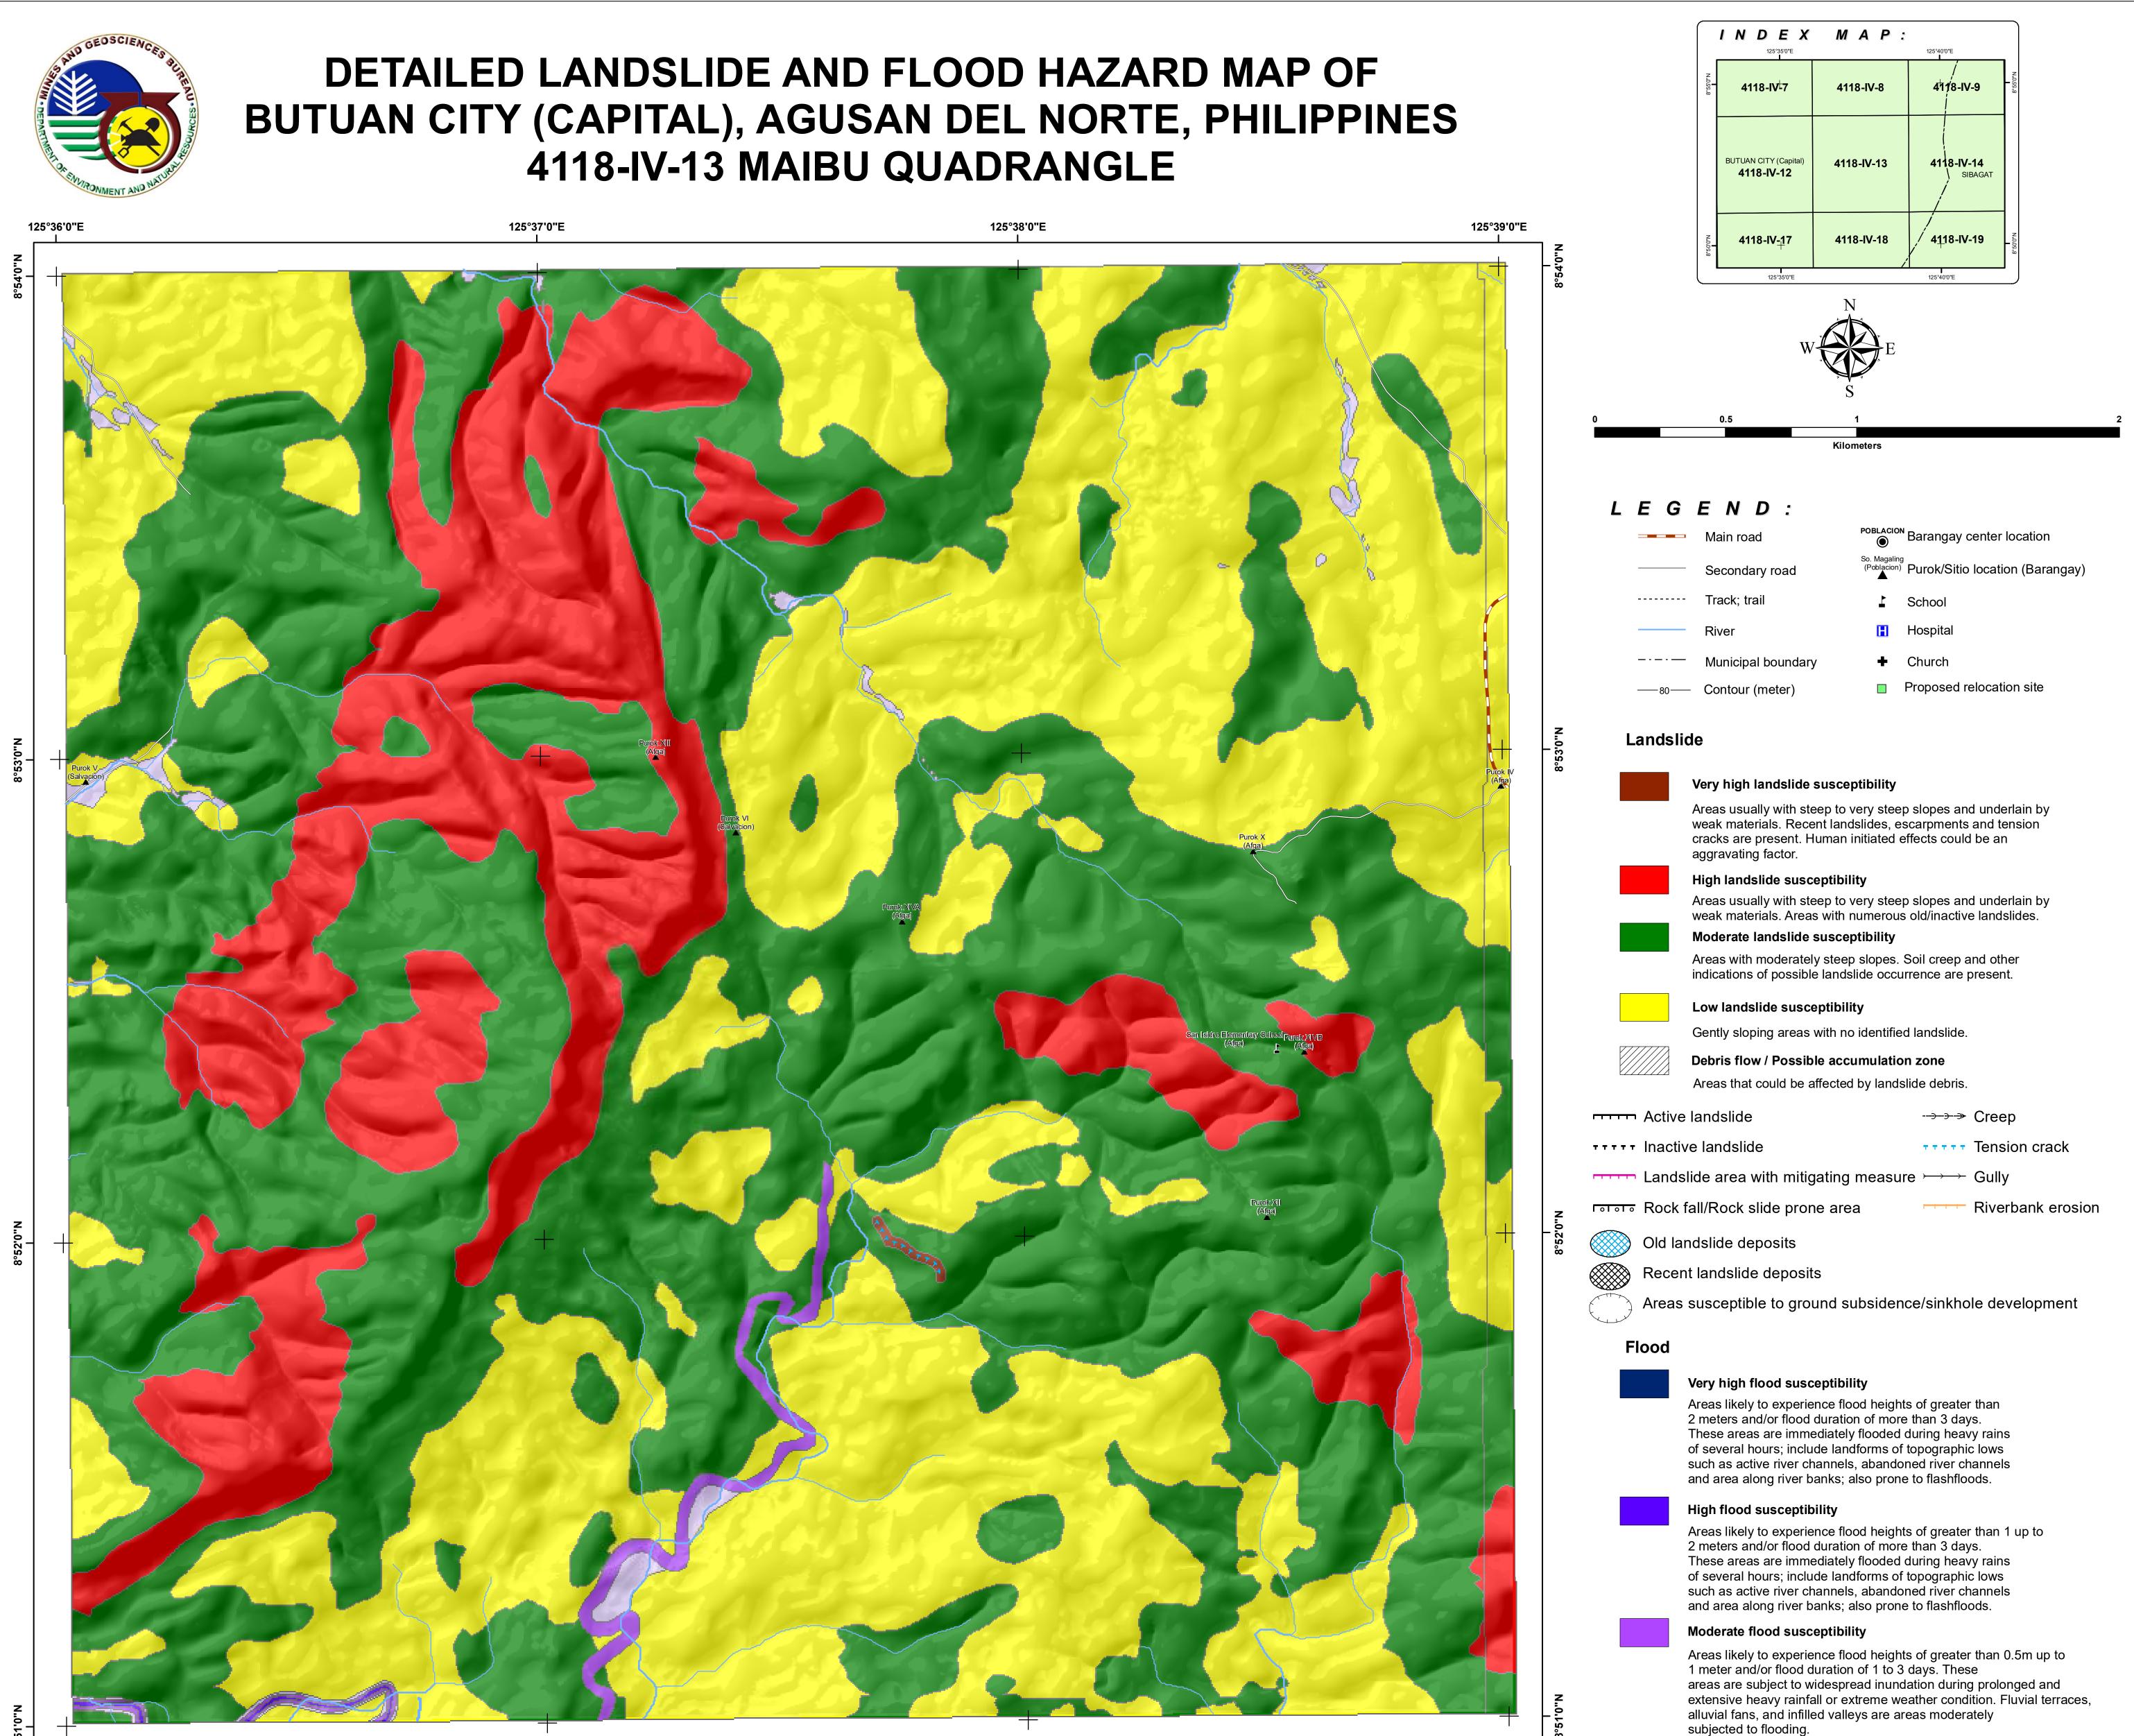
Mapping scale 1:10,000

Low flood susceptibility

Areas likely to experience flood heights of 0.5 meter or less and/or flood duration of less than 1 day. These areas include low hills and gentle slopes. They also have sparse to moderate drainage density.

Direction of rising floodwater Direction of receding floodwater

$\overset{1.2}{\otimes}$ Flood depth (meter)

Flashflood exit point
