DEPARTMENT OF ENVIRONMENT AND NATURAL RESOURCES MINES AND GEOSCIENCES BUREAU North Avenue, Diliman, Quezon City

Mapping scale 1:10,000

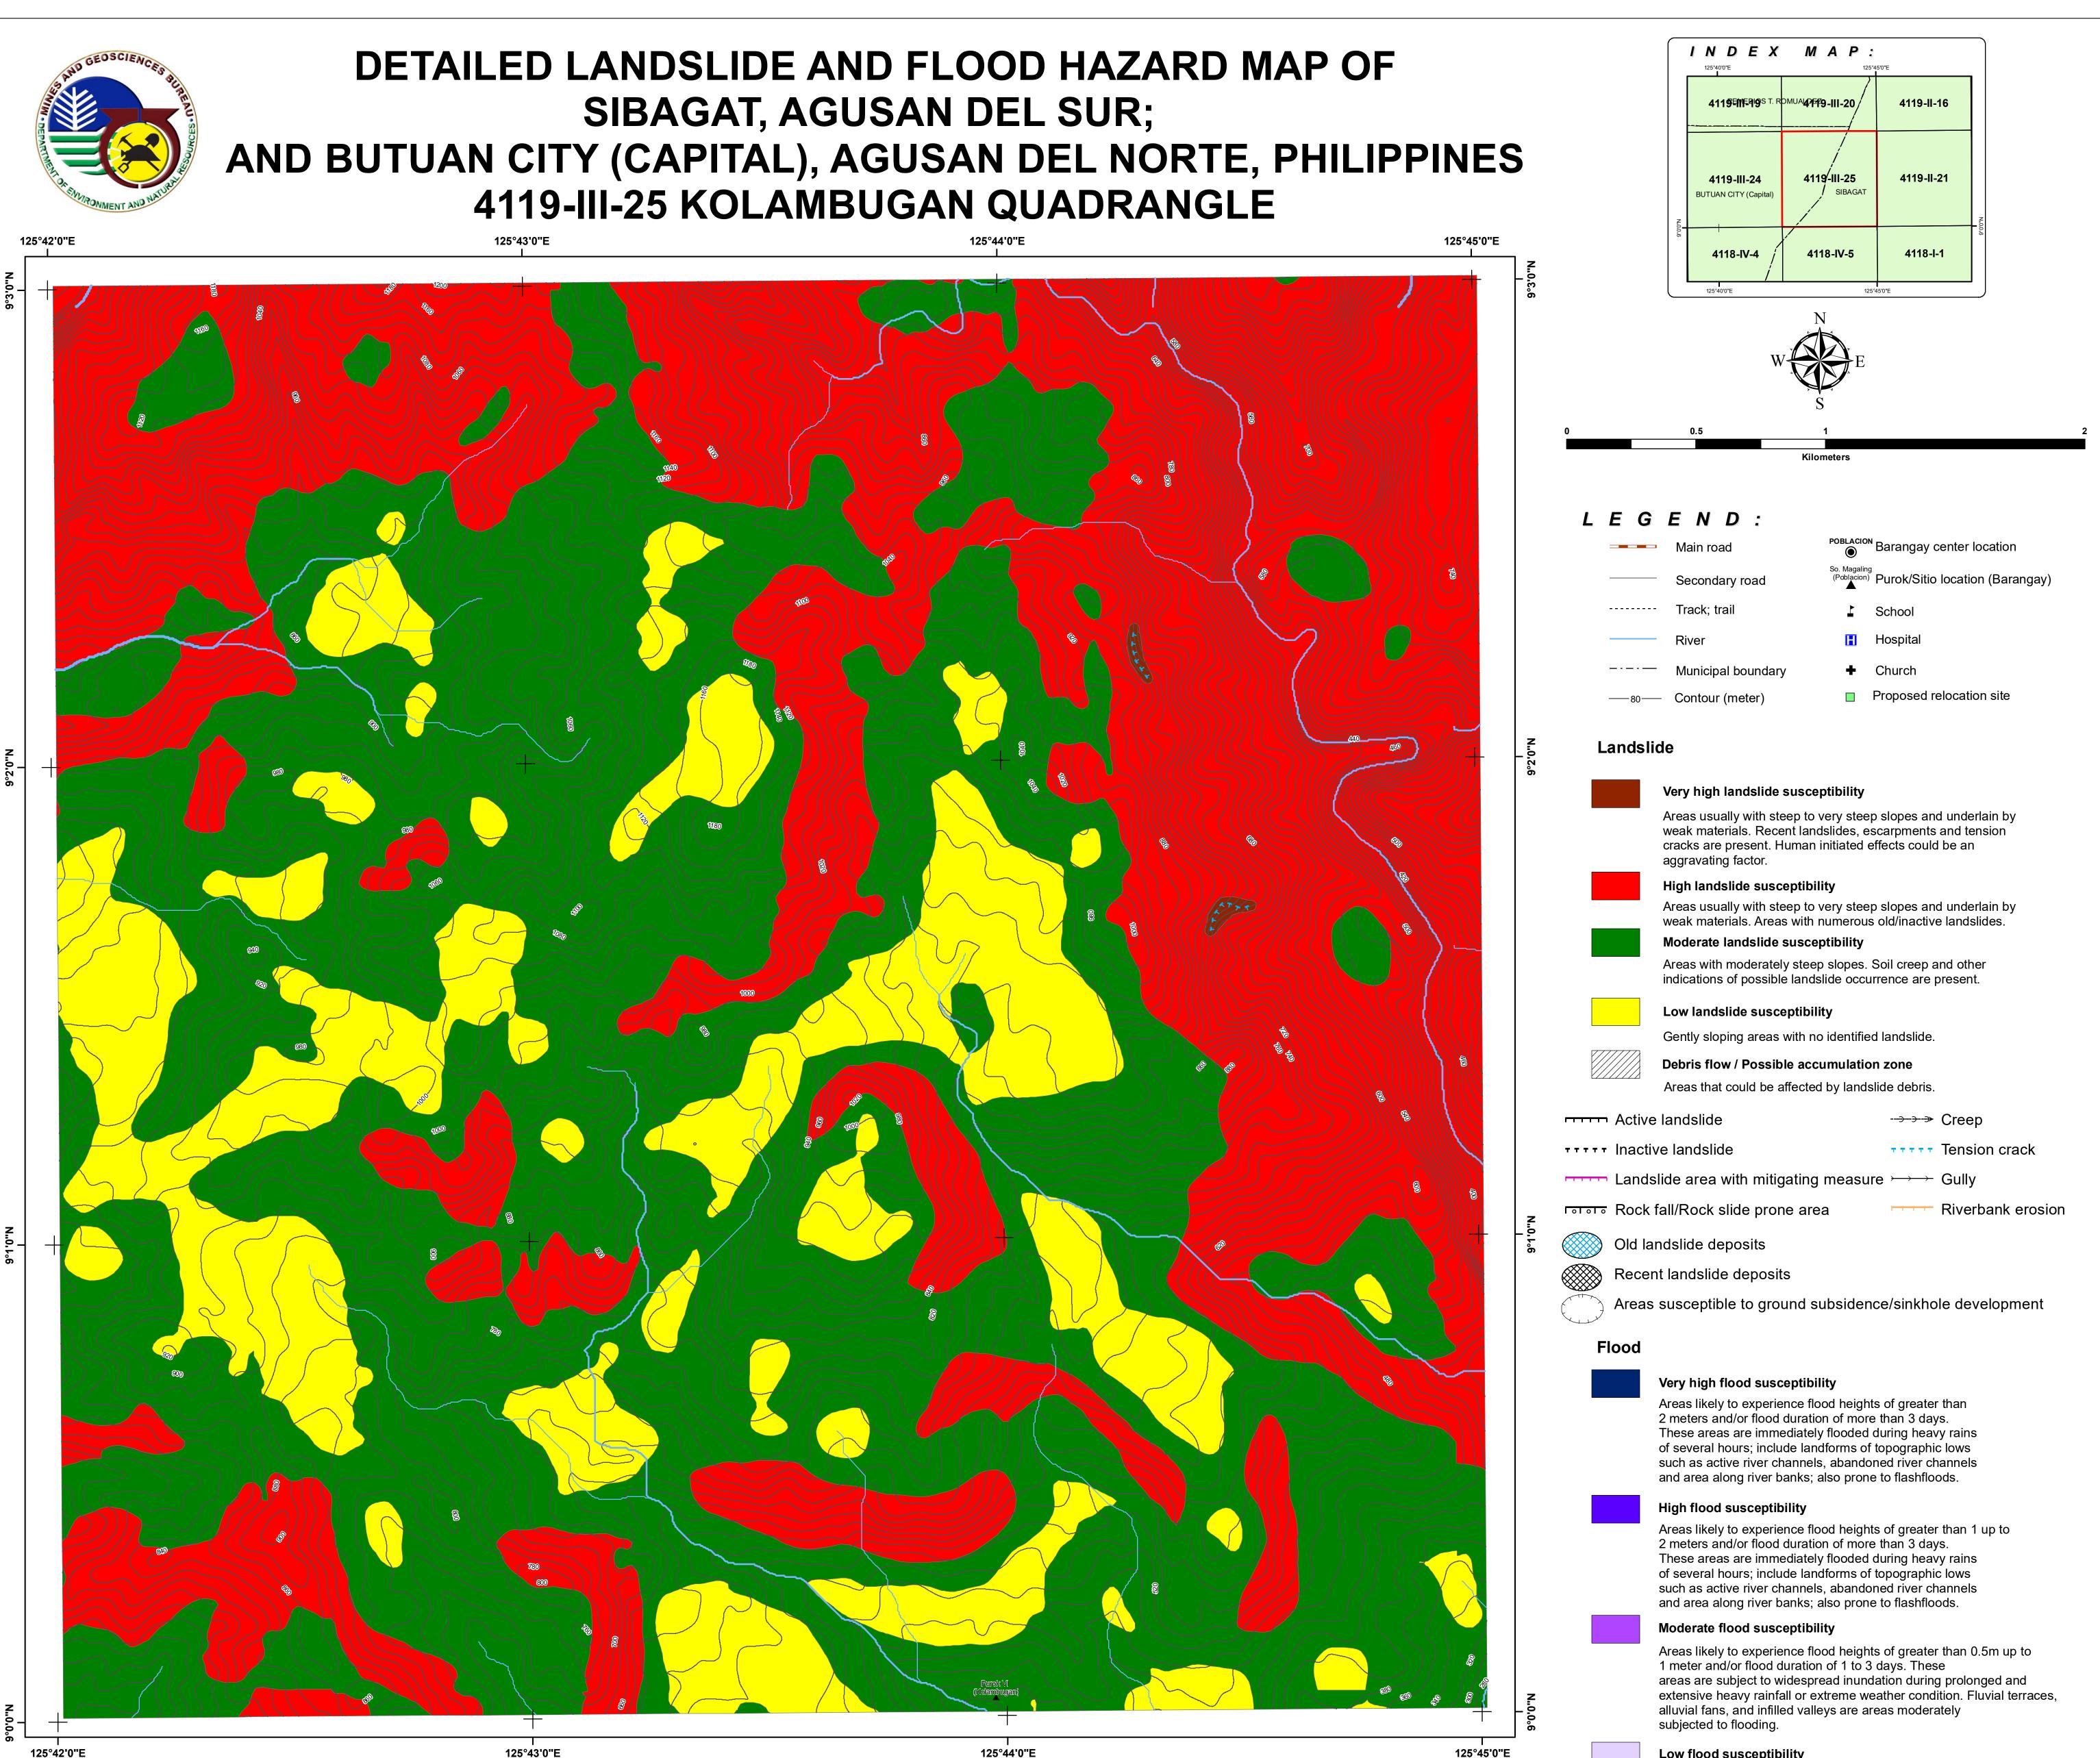
Low flood susceptibility

Areas likely to experience flood heights of 0.5 meter or less and/or flood duration of less than 1 day. These areas include low hills and gentle slopes. They also have sparse to moderate drainage density.

Direction of rising floodwater Direction of receding floodwater

$\overset{1.2}{\otimes}$  Flood depth (meter)

Flashflood exit point
