# DETAILED LANDSLIDE AND FLOOD HAZARD MAP OF LIBJO, DINAGAT ISLANDS, PHILIPPINES **4121-III-7 SAN JOSE QUADRANGLE**

DEPARTMENT OF ENVIRONMENT AND NATURAL RESOURCES **MINES AND GEOSCIENCES BUREAU** North Avenue, Diliman, Quezon City

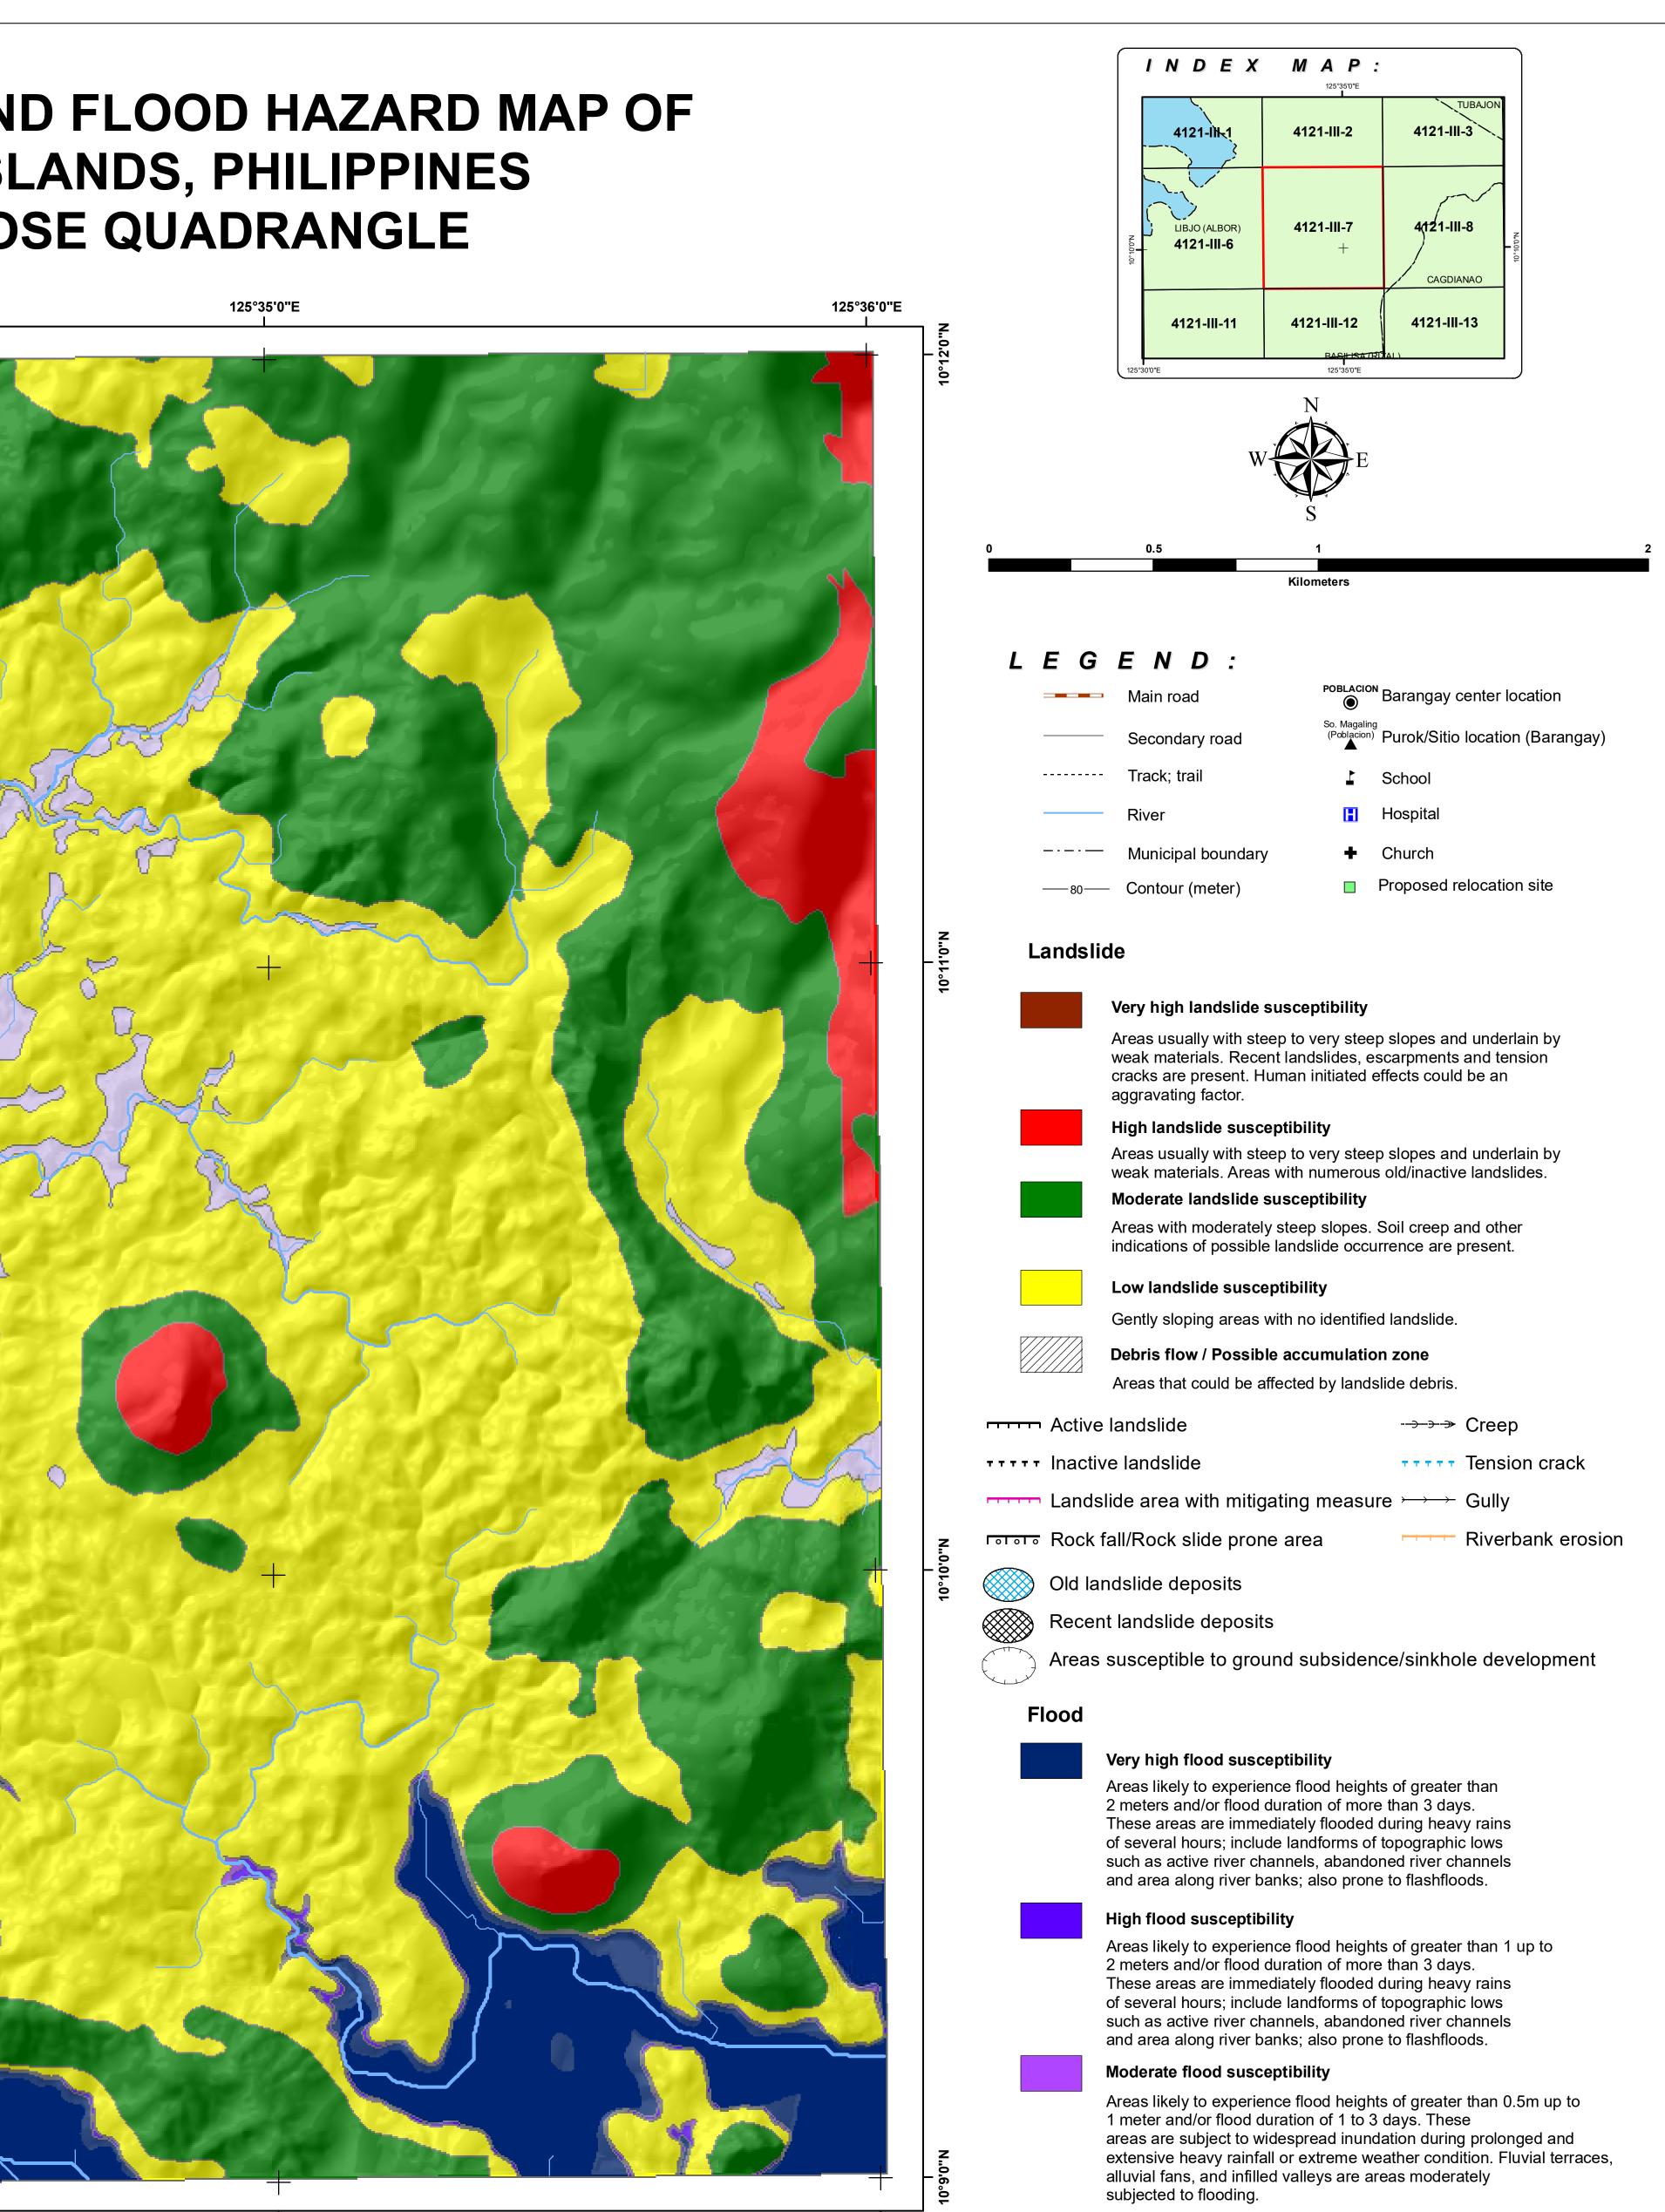
Mapping scale 1:10,000
