GEOHAZARD MAP 4121-IV-19 QUADRANGLE

Department of Environment and Natural Resources
MINES AND GEO-SCIENCES BUREAU

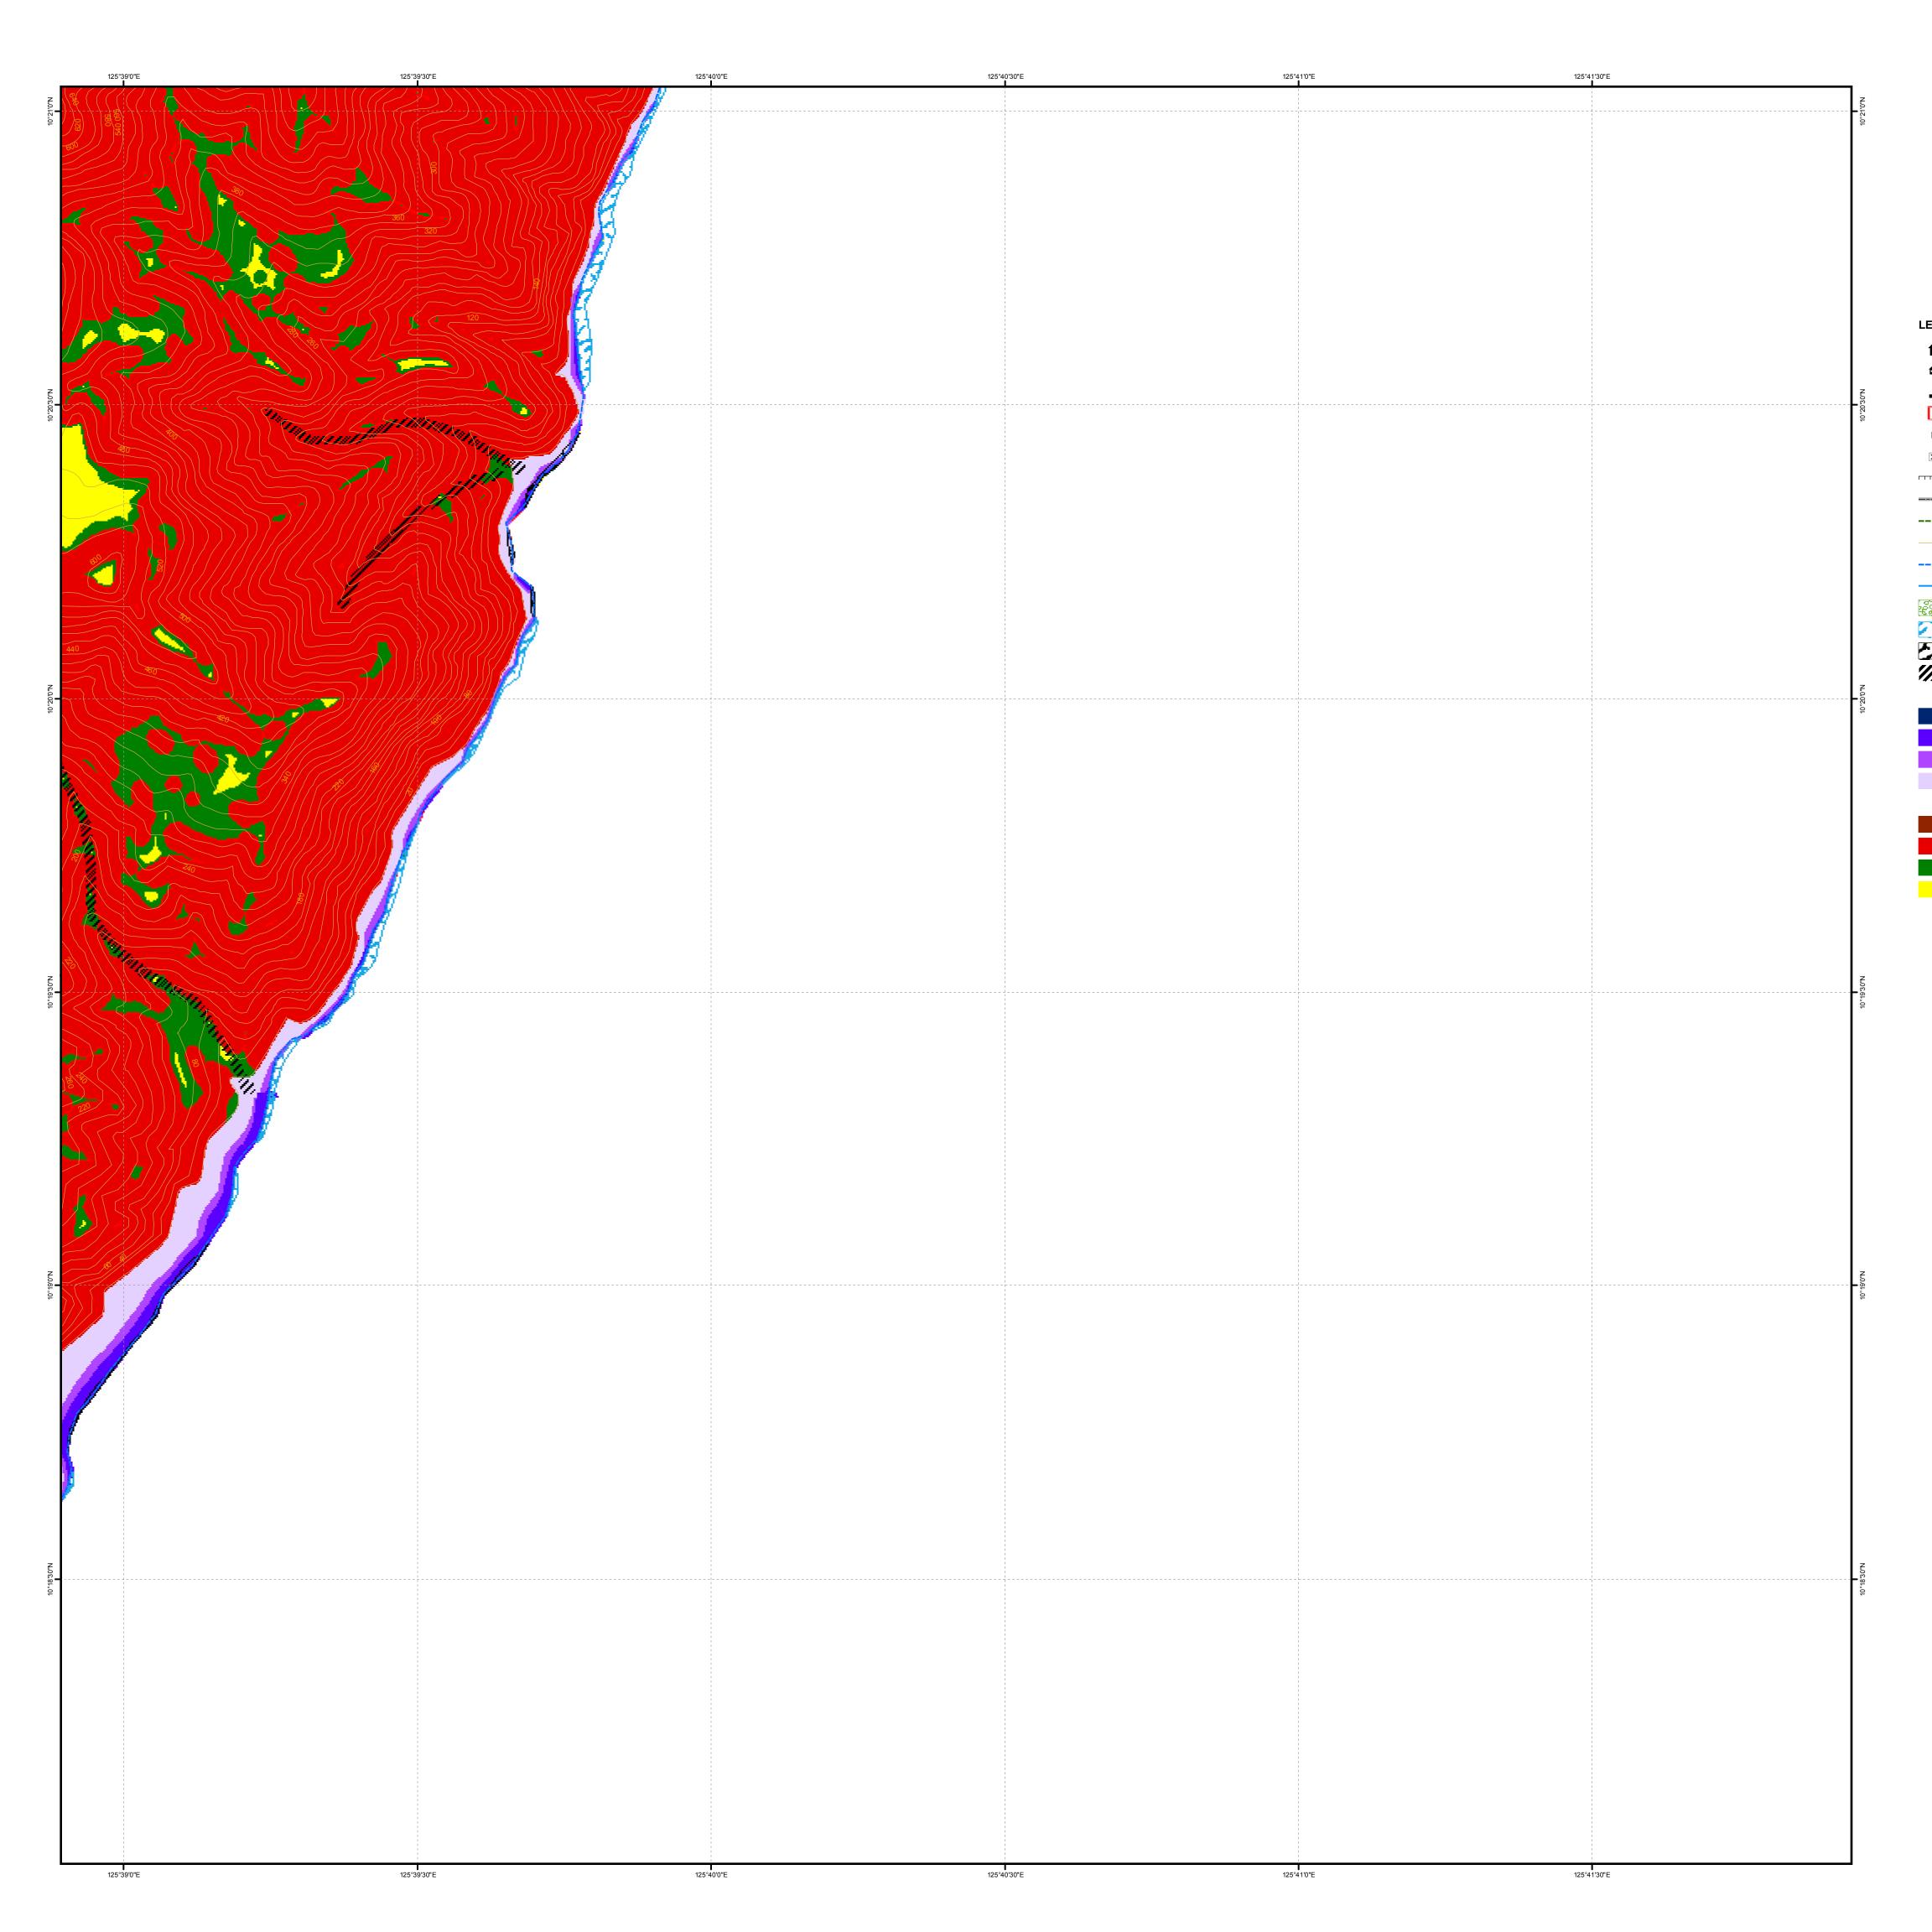
VERY HIGH
Areas usually with steep to very steep slopes and underlain by
weak materials. Recent landslides, escarpments and tension
cracks are present. Human initiated effects could be an
aggravating factor.

Areas usually with steep to very steep slopes and underlain by weak materials. Areas with numerous old and inactive landslides.

Areas with moderately steep slopes. Soil creep and other indications for possible landside occurrence are present.

Areas for which the combination of factors is likely to create adverse flood and inundation problems. This category includes areas along large streams with very small channel slopes and broad floodplains; landforms of topographic lows, particularly active river systems, deltas abandoned river channels, and areas adjacent to river banks; also include portions of the river system where channels are perched due to repeated deposition of sediments; and part of the coastal areas affected by storm surge and fluctiating sea

MODERATE
Areas for which the combination of factors is less likely to create serious flood problems. These areas are the less-inundated of the floodplains, deltas river terraces, and old channels; also include the less flood-prone areas near the coast.

Areas for which the combination of factors is unlikely to create serious flood problems; include low lying topographic landforms least affected by flood and inundation.
