GEOHAZARD MAP 4121-IV-9 QUADRANGLE

DINAGAT PROVINCE INDEX MAP

Department of Environment and Natural Resources
MINES AND GEO-SCIENCES BUREAU

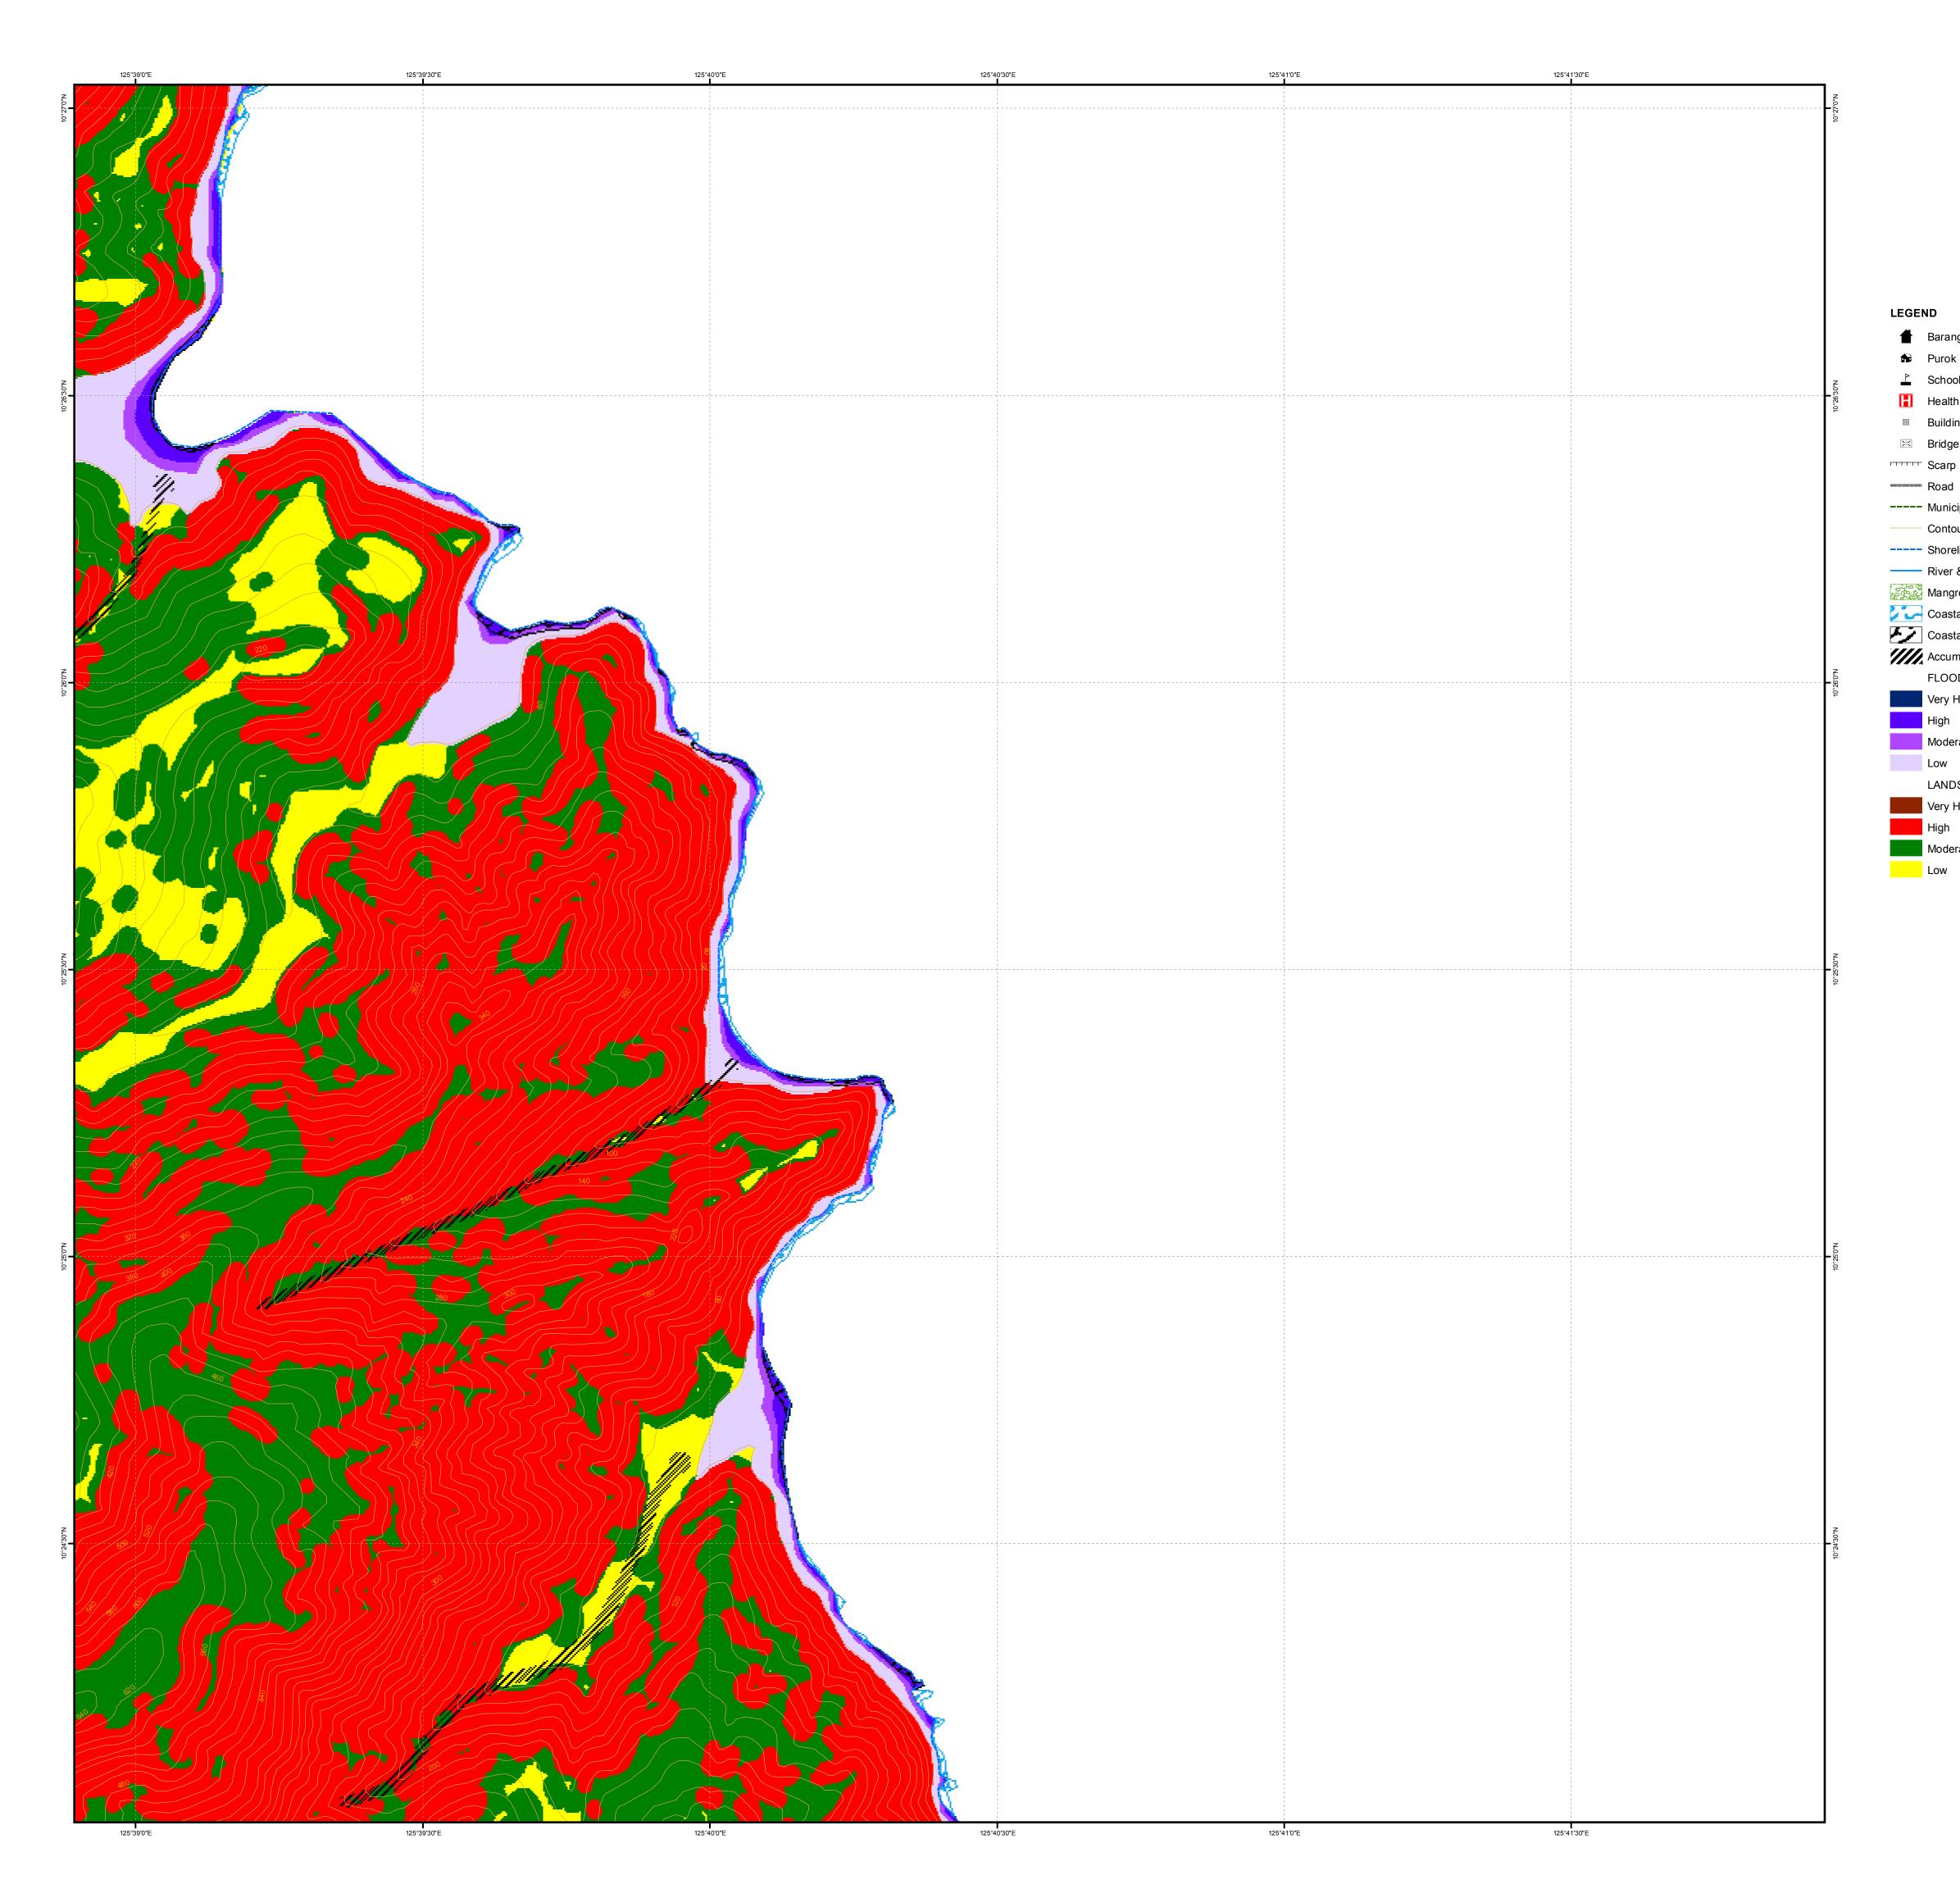
Barangay **LANDSLIDE** VERY HIGH Areas usually with steep to very steep slopes and underlain by weak materials. Recent landslides, escarpments and tension cracks are present. Human initiated effects could be an aggravating factor. Purok School Health Facility Areas usually with steep to very steep slopes and underlain by weak materials. Areas with numerous old and inactive landslides. Building Bridge Areas with moderately steep slopes. Soil creep and other indications for possible landside occurrence are present. LOW Gently sloping areas with no identified landslides. ---- Municipal Boundary Contour (20m) ---- Shoreline Areas for which the combination of factors is likely to create adverse flood and inundation problems. This category includes areas along large streams with very small channel slopes and broad River & Creeks floodplains; landforms of topographic lows, particularly active river systems, deltas abandoned river channels, and areas adjacent to river banks; also include portions of the river system where channels are perched due to repeated deposition of sediments; and part of the coastal areas affected by storm surge and fluctiating sea Mangrove Area Coastal Errosion Coastal Accretion MODERATE Areas for which the combination of factors is less likely to create serious flood problems. These areas are the less-inundated of the floodplains, deltas river terraces, and old channels; also include the less flood-prone areas near the coast. Accumulation Zone FLOOD PRONE SUSCEPTIBILITY LOW Areas for which the combination of factors is unlikely to create serious flood problems; include low lying topographic landforms least affected by flood and inundation. LANDSLIDE SUSCEPTIBILITY
