# DETAILED LANDSLIDE AND FLOOD HAZARD MAP OF 4120-III-21 MAGSAYSAY QUADRANGLE

**MINES AND GEOSCIENCES BUREAU**

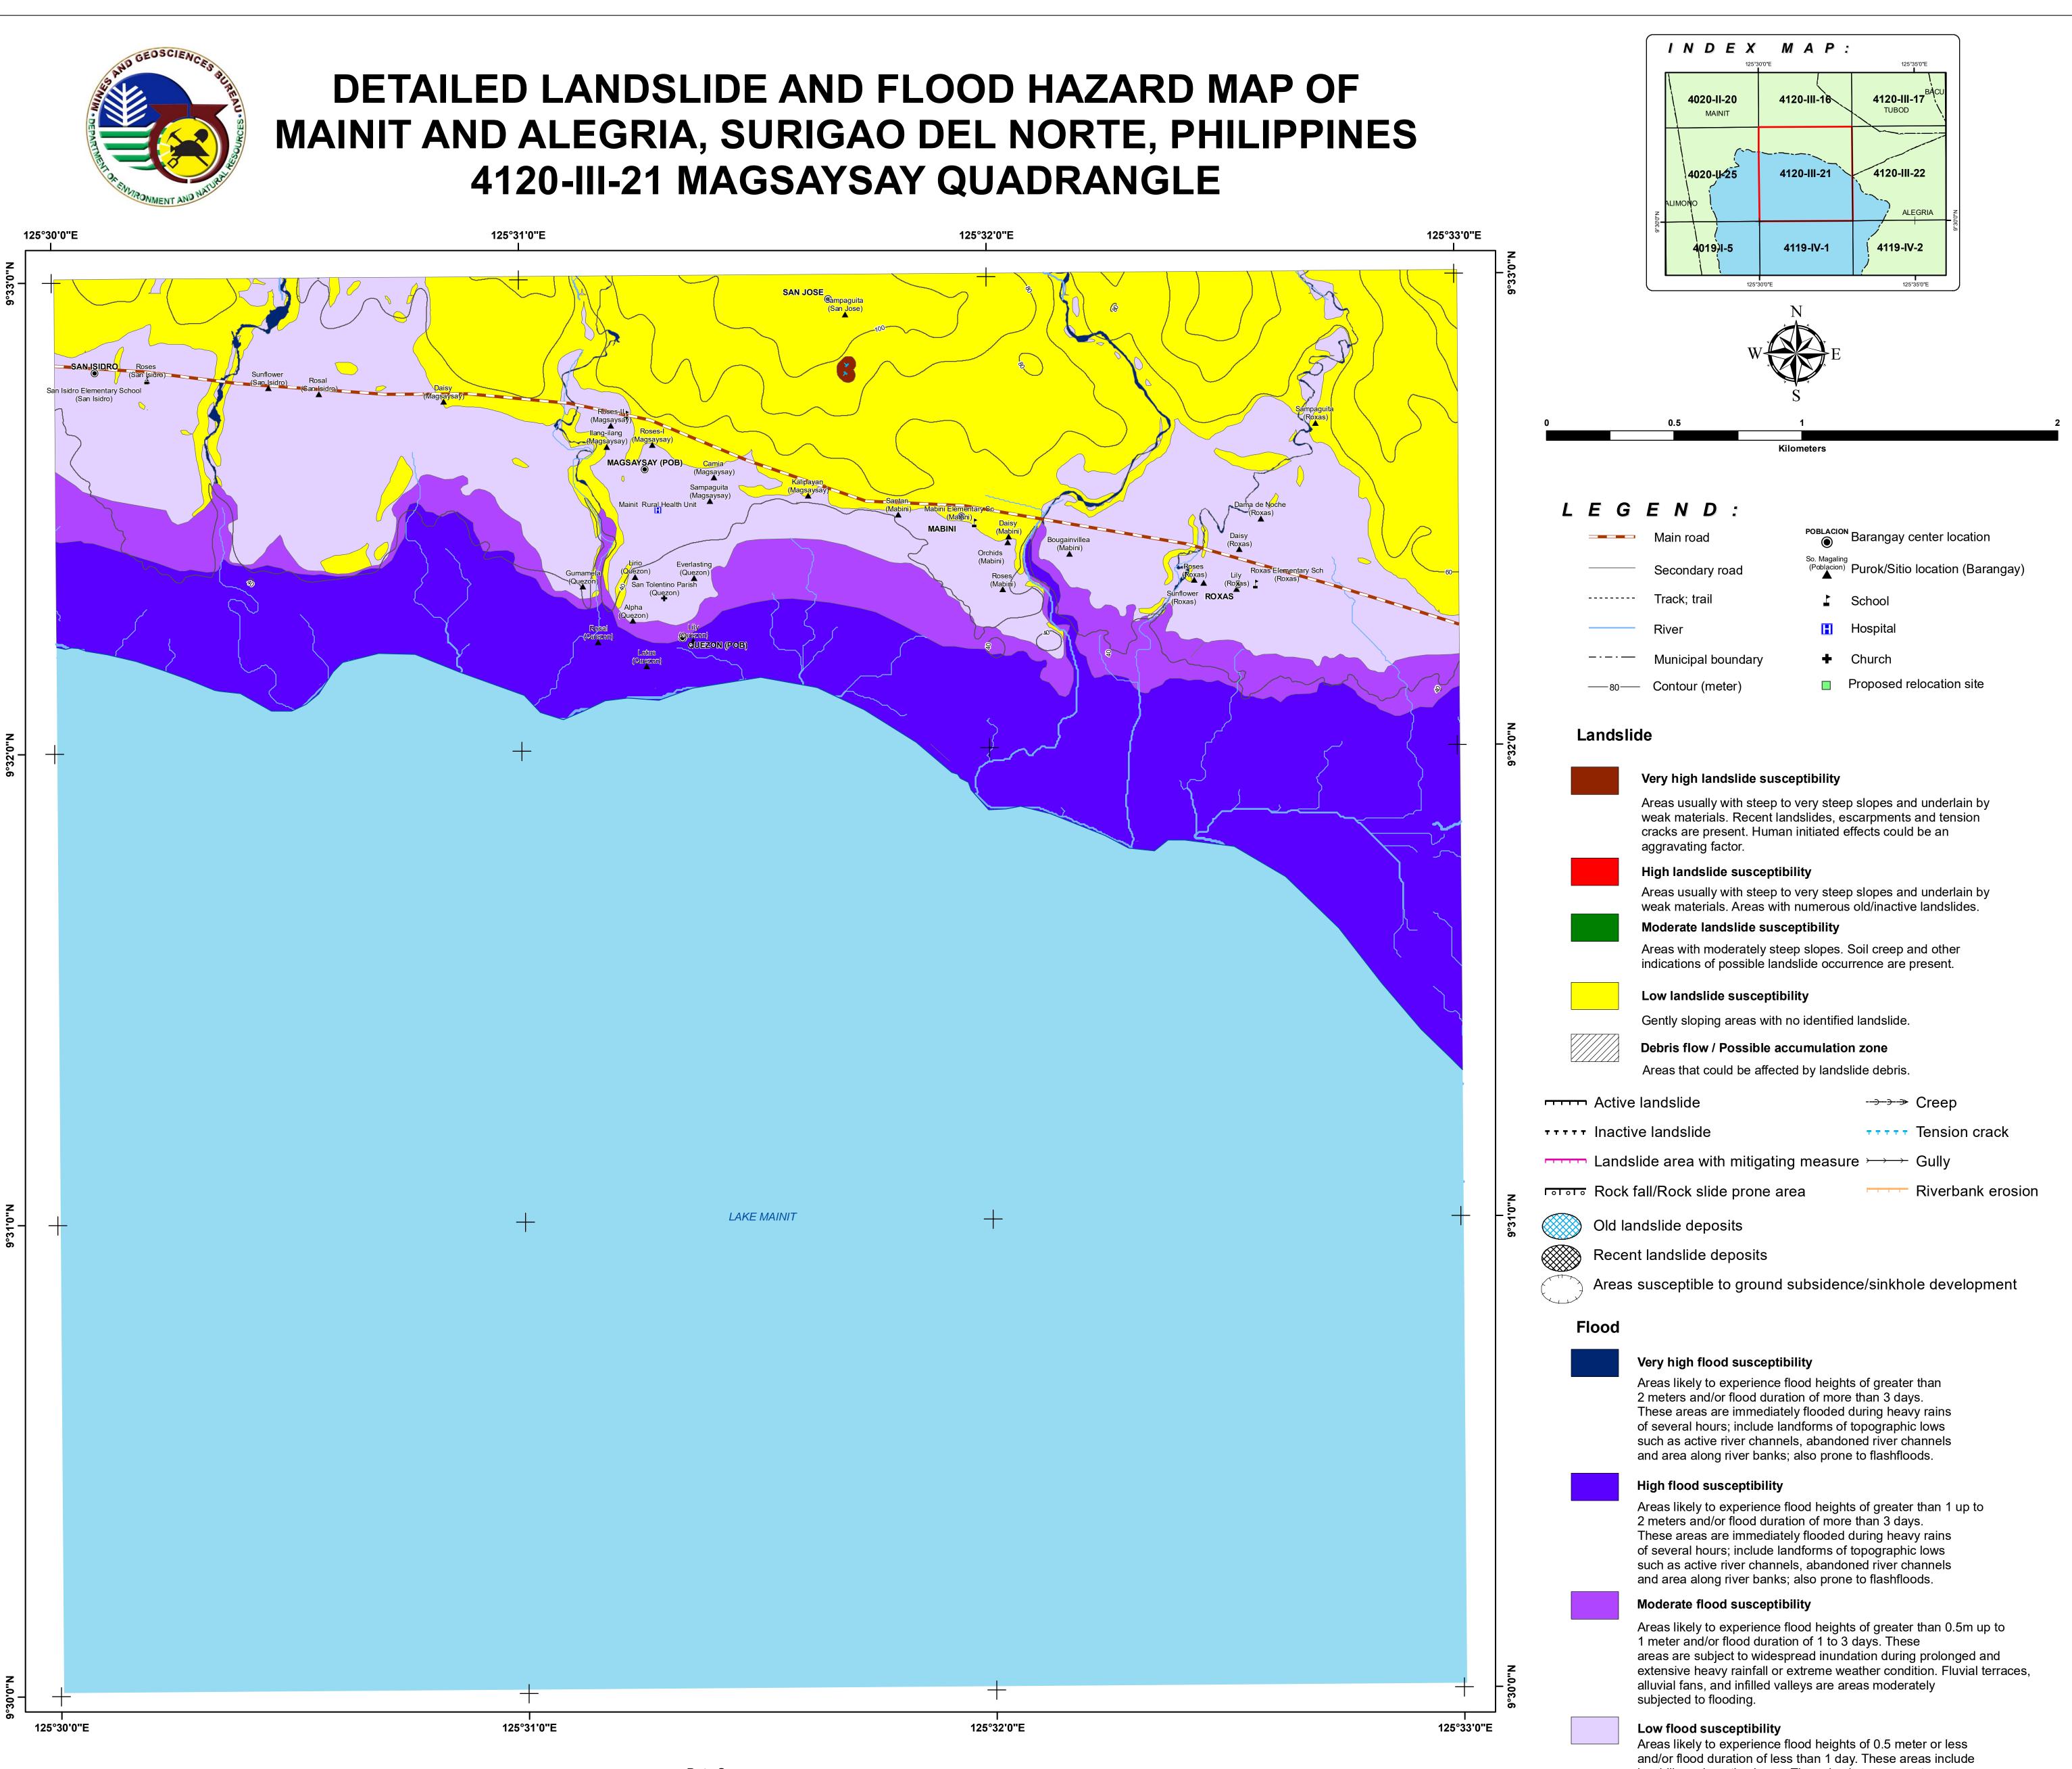
Mapping scale 1:10,000

low hills and gentle slopes. They also have sparse to moderate drainage density.

# Direction of rising floodwater Direction of receding floodwater

$\overset{1.2}{\otimes}$  Flood depth (meter)

Flashflood exit point
